BGET Trip report
Nov 29 to 1 December 2005

Trip goals:

- Micro-hydro site survey at Huai Kra Thing
- Ram pump survey at Mae U Su
- Determine cause of low power at Mae Sa Pau micro-hydro and fix if possible.

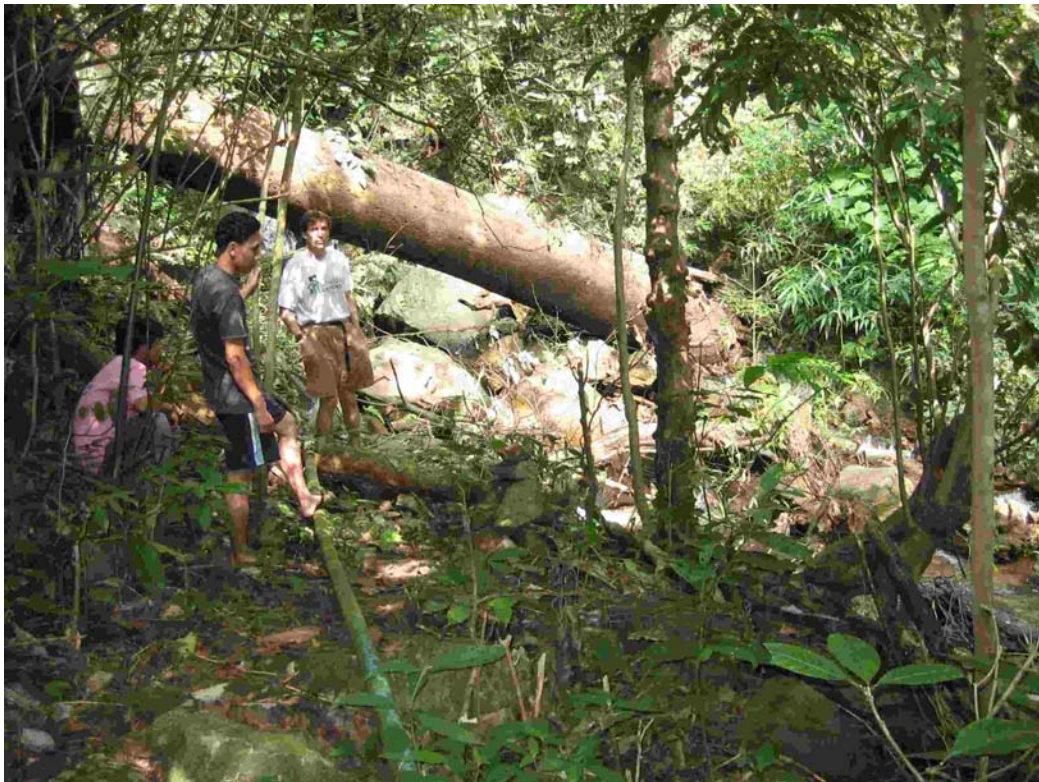
Pic 1 ([Back](#))

This time we re-surveyed the stream using a tape and inclinometer, and we selected preferred locations for powerhouse and intake. We found the gross head to be 38 meters and distance (following the stream bed) to be 153 meters. The preferred powerhouse location is marked with a stone cairn (**pic 1**). It's more than 2 meters above the stream level (and about half a meter above the 30-year flood level that our local guide reported). The intake will be situated above a waterfall. We found a midstream "permanent" rock formation and large tree that may be useful in constructing a partial weir. A nearby excavate-able bank is suitable for a siltation tank. We used the bucket method to measure streamflow at 53.9 liters/second (average of 3 trials).

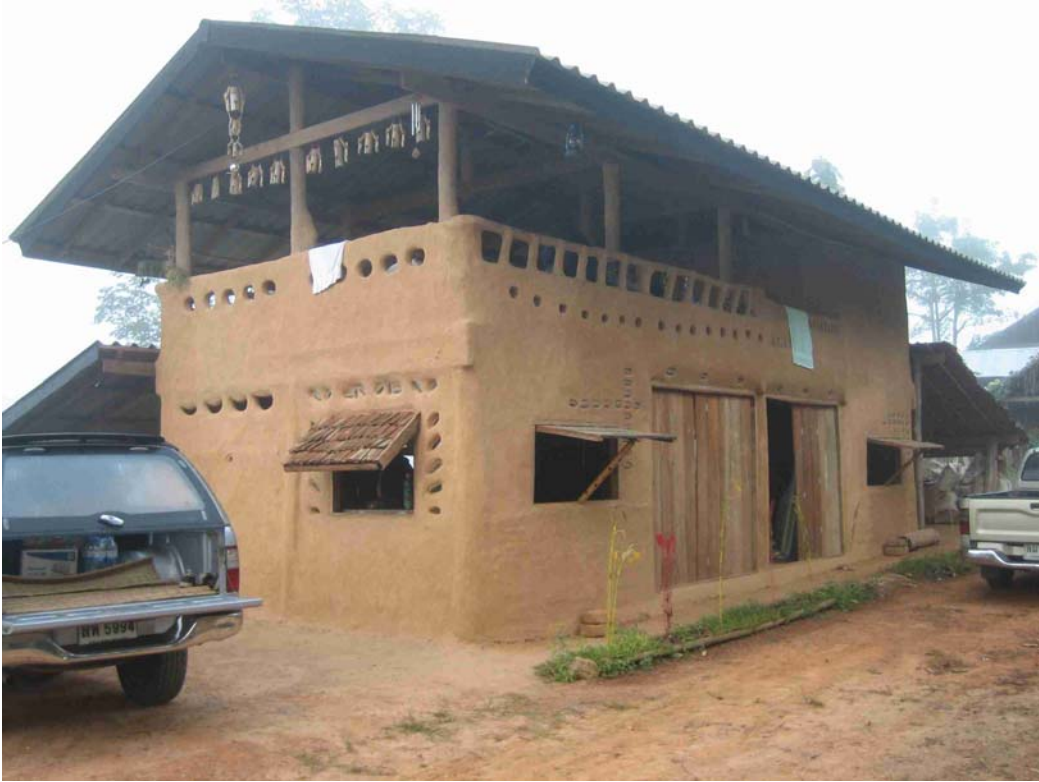
Pic 2 ([Back](#))

After a late lunch we drove to Mae U Su, arriving in the late afternoon. We stayed in a beautiful adobe house (**pic 2**) built by a local Karen man named "David" or "Thawet". David works with Jon, a young French fellow. Together they're putting together a large training centre to train Karen on organic farming. They were interested in having BGET build them a hydraulic ram pump to provide water for bathing and agriculture.

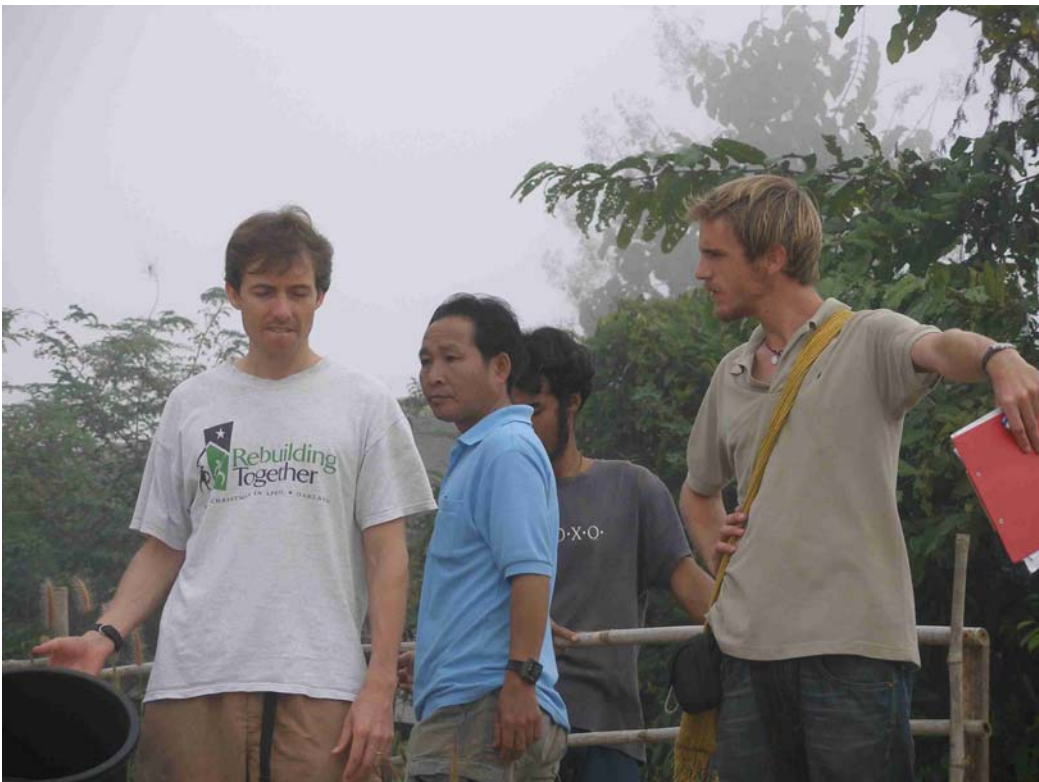
Pic 3 ([Back](#))

We inspected the Mae U Su site: the dormitories and training center, orchards, sports field, meal area. All is under construction and only a few foundations and a water tank are in place now. Then we went to see the river that would be the water source for the ram (**pic 3**).

Unfortunately, it just isn't a good site, or at least not suitable for the first ram pump installation we try. The water source is a big, fairly flat river. Getting a few meters of drive head would take a channel over a hundred meters long. The water tanks that we needed to pump to are 38 meters higher than the river surface.

We discussed a number of possibilities and ended up with a solar water pump as one option. Another, perhaps less expensive and more sustainable option, would be to extend a water supply pipe about 4 km to another water source at an elevation higher than the water tanks. We decided to try to find another location for BGET's first ram pump.

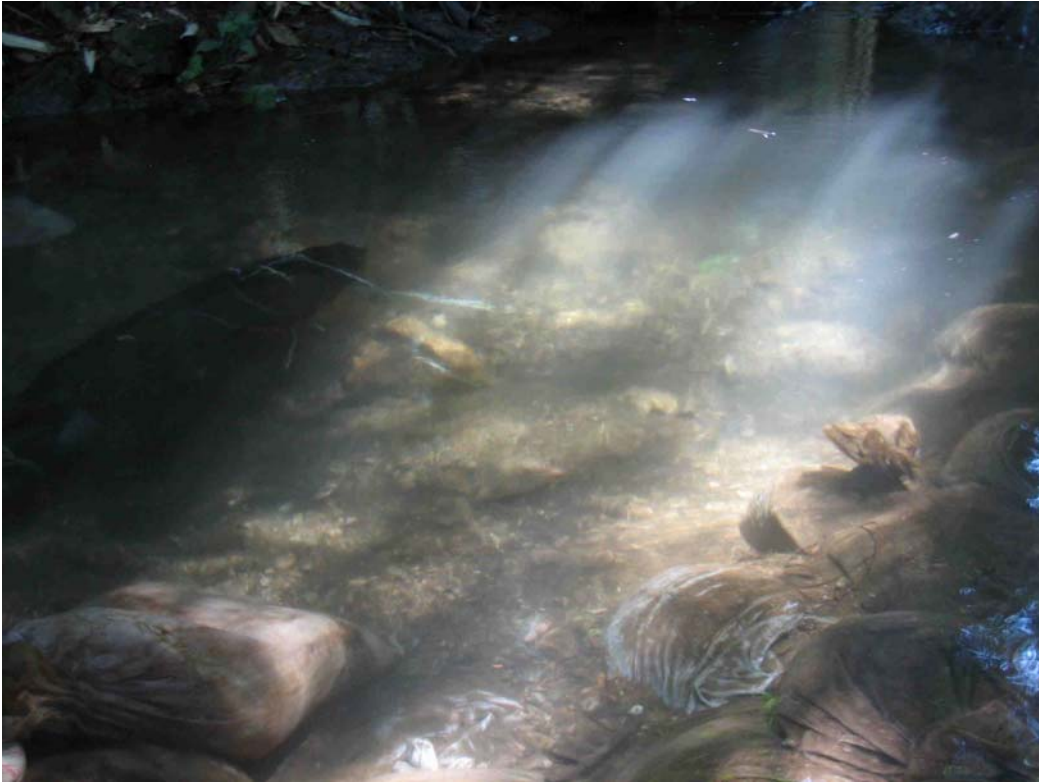
Pic 4 ([Back](#))

Spent the day working to improve the micro-hydro. We found that with the valve open, the turbine spun up to 300 volts or so... and then in the course of a few minutes dropped to zero and the water dropped to a trickle and the pipe was mostly filled with air (entering from the nozzle). Culprit: blocked pipe at the inlet. We cleaned out hundreds of buckets of muck (bark, leaves, twigs, silt) that had settled in the “reservoir” at the top of the waterfall.

Then we rebuilt the intake filter, which had clogged up with leaves. It was grossly deficient: just a piece of mesh across the 4” pipe inlet. We used bamboo and mild steel wire to sew a basket of plastic mesh about the size of a medium sized pig (at least a hundred-fold increase in intake filter surface area). We fastened the mouth of the basket to the pipe inlet and kept it from floating by tying it down with two rocks (pic 4). Result: pipe didn’t fill up with air anymore.
